# Manhole Inspection Summary

Manhole # S43C2\_012MH

Insp Date: **12/13/07 8:10 AM**

**Location** Address: **Tompkins St.**

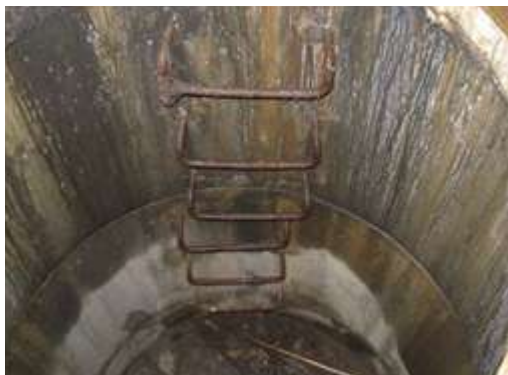
Steps

**Steps** Count: **6** Missing: **0** ☐ Corroded

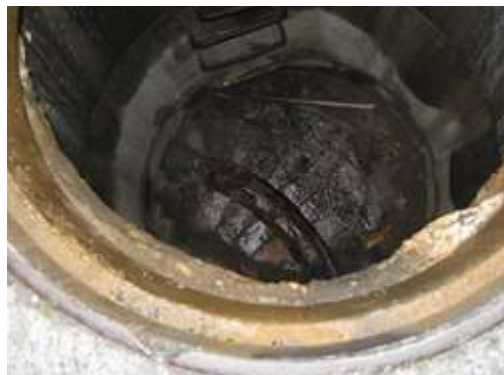
Defect 1

**Frame** Offset: **1.5** (in.) Condition: ☒ Sound ☐ Cracked ☐ Leaks

Frame offset

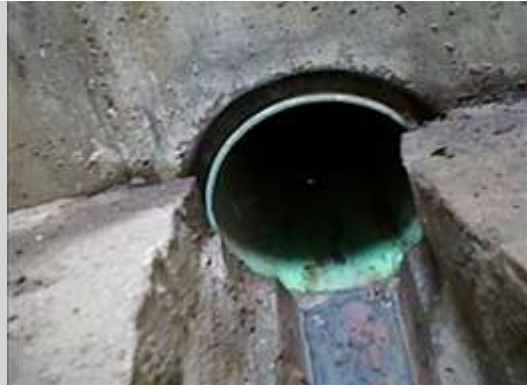
12 O'Clock Outflow

8 in. Circular Gravity Sewer  
Pipe Out @ 12 O'Clock

Pipe Height: **10.8** (in.) Rod and Bar (Angled)  
Pipe Material: **PVC** ☐ Pipe Lined  
Invert Depth: **9.06** (ft.) Flow Characteristics: **None**  
Deposits: ☒ None ☐ Mud ☐ Sludge ☐ Debris ☐ Grease  
Silt Depth: (in.) Deposits Extent:  
Infiltration: **None** Pipe Seal Cond: **Sound**

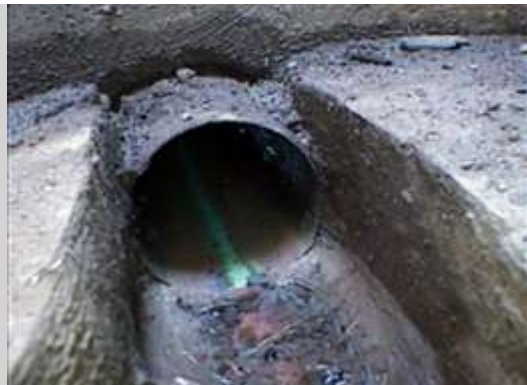
4 O'Clock Inflow

6 in. Circular Service Sewer  
Pipe In @ 4 O'Clock

Pipe Height: **7.2** (in.) Rod and Bar (Angled)  
Pipe Material: **PVC** ☐ Pipe Lined  
Invert Depth: **8.68** (ft.) Flow Characteristics: **None**  
Deposits: ☒ None ☐ Mud ☐ Sludge ☐ Debris ☐ Grease  
Silt Depth: (in.) Deposits Extent:  
Infiltration: **None** Pipe Seal Cond: **Sound**
